GAMHERSA
S.A. DE C.V.

PRACTICAL SOLUTIONS
FOR ANY KIND OF
TECHNOLOGY WESP AND
LEAD EQUIPMENT IN
GENERAL.

Topic 1: Alteration of original design and manufacturing of:

Topic 2: Preventive maintenance of Wet electrostatic precipitators
WESP and discharge electrodes for WESP.

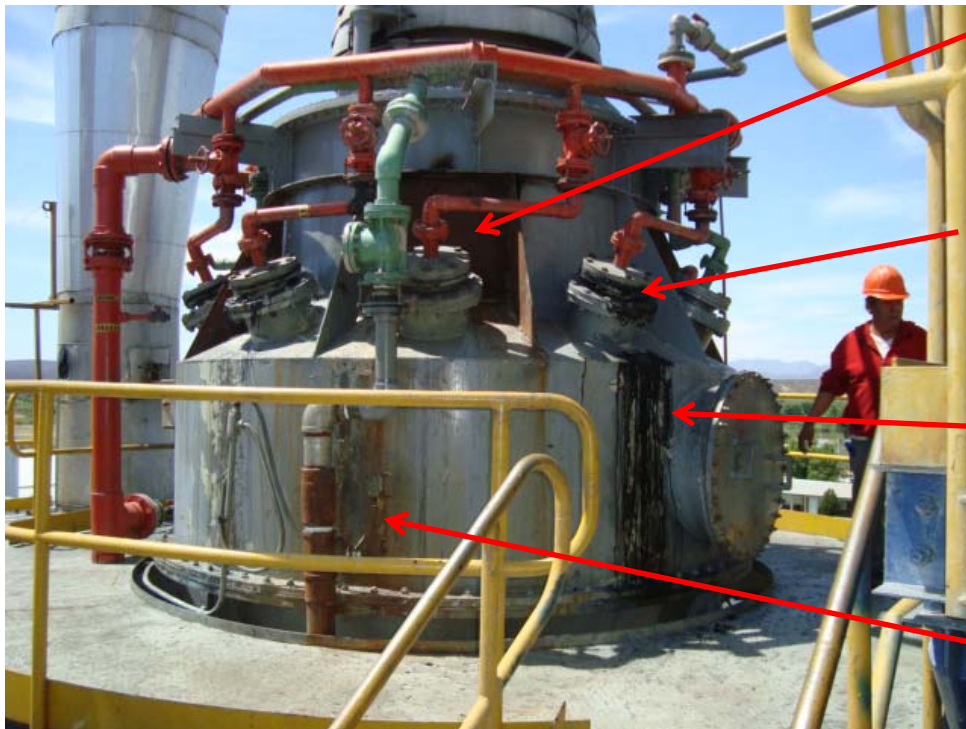
- Constant presence of acid on the external side of the equipment.
- False air intake in the flux and variations in temperature.
- High risk of steel deformation due to corrosion.
- Internal collapsing of cement and brick because of the accumulation of sulphate, provoking steel exposure.

Installation of a steel homogenized lead surface with 6 mm. of thickness everywhere with possible contact with the flux.

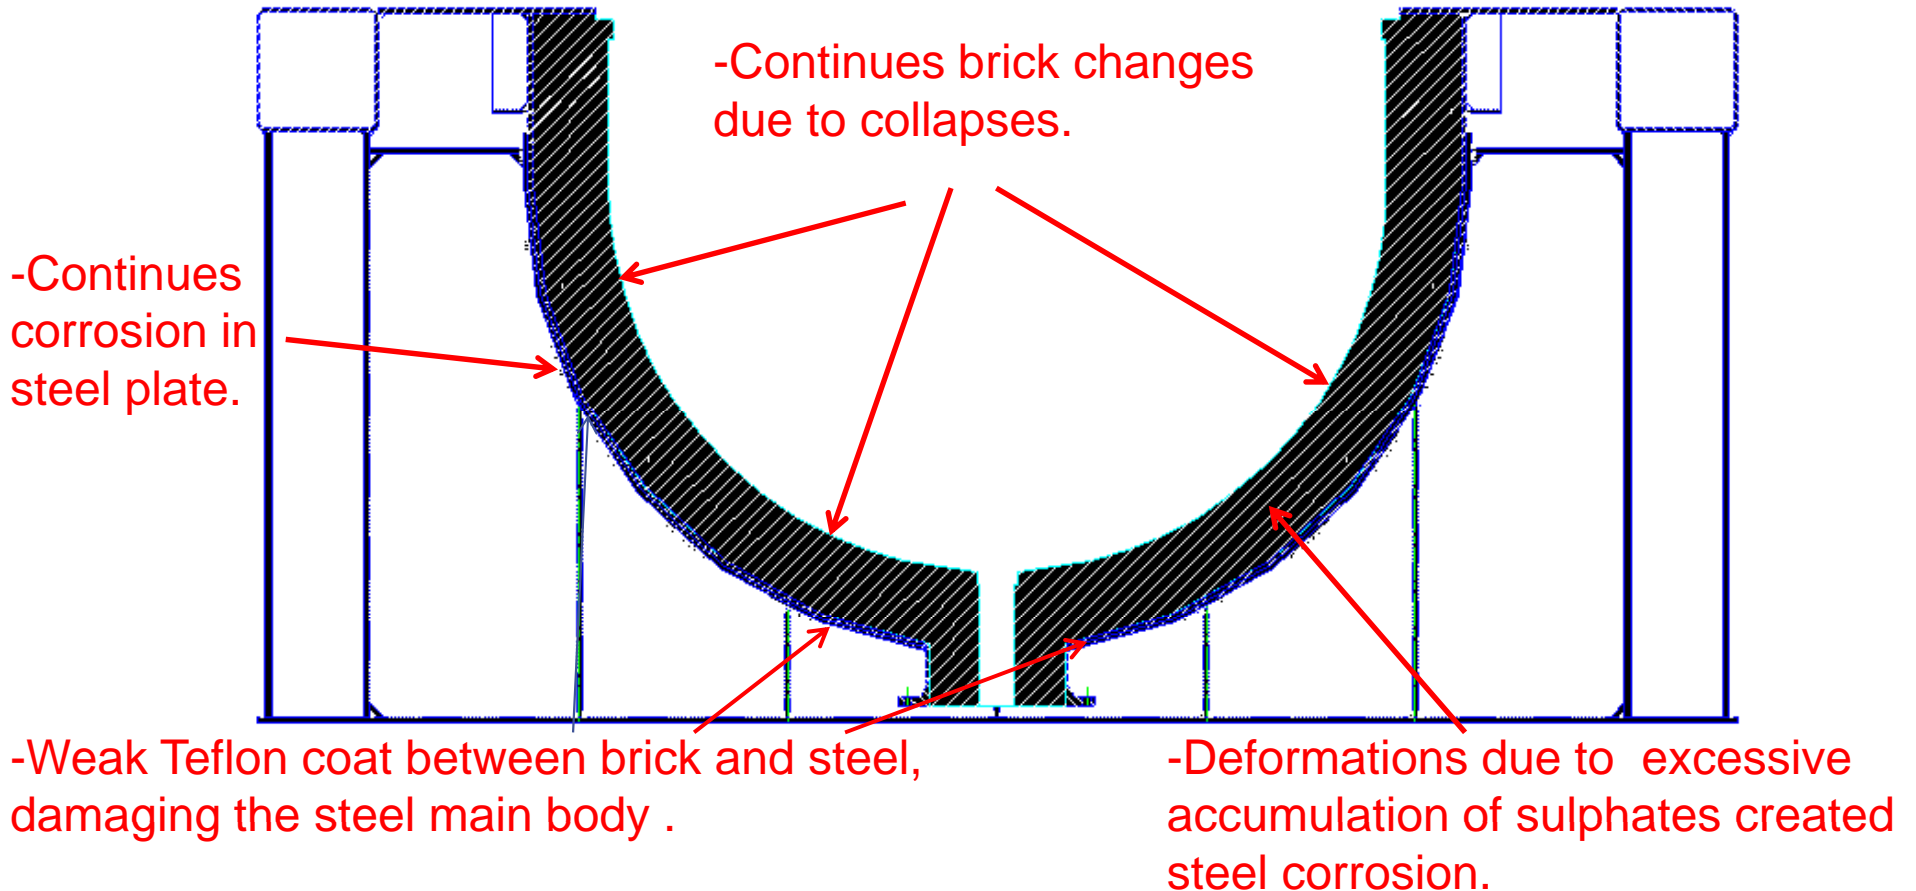
Causes that originate the design alterations:

- Dismantling of damaged bottom condenser
- Repairing the bottom condenser removing corroded steel sections.
- Installation of a steel homogenized lead surface with 6 mm. of thickness everywhere with possible contact with the flux.

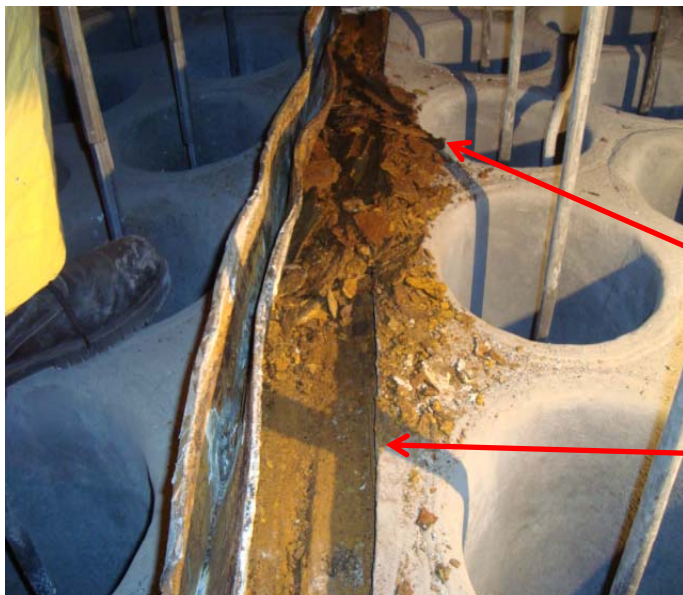
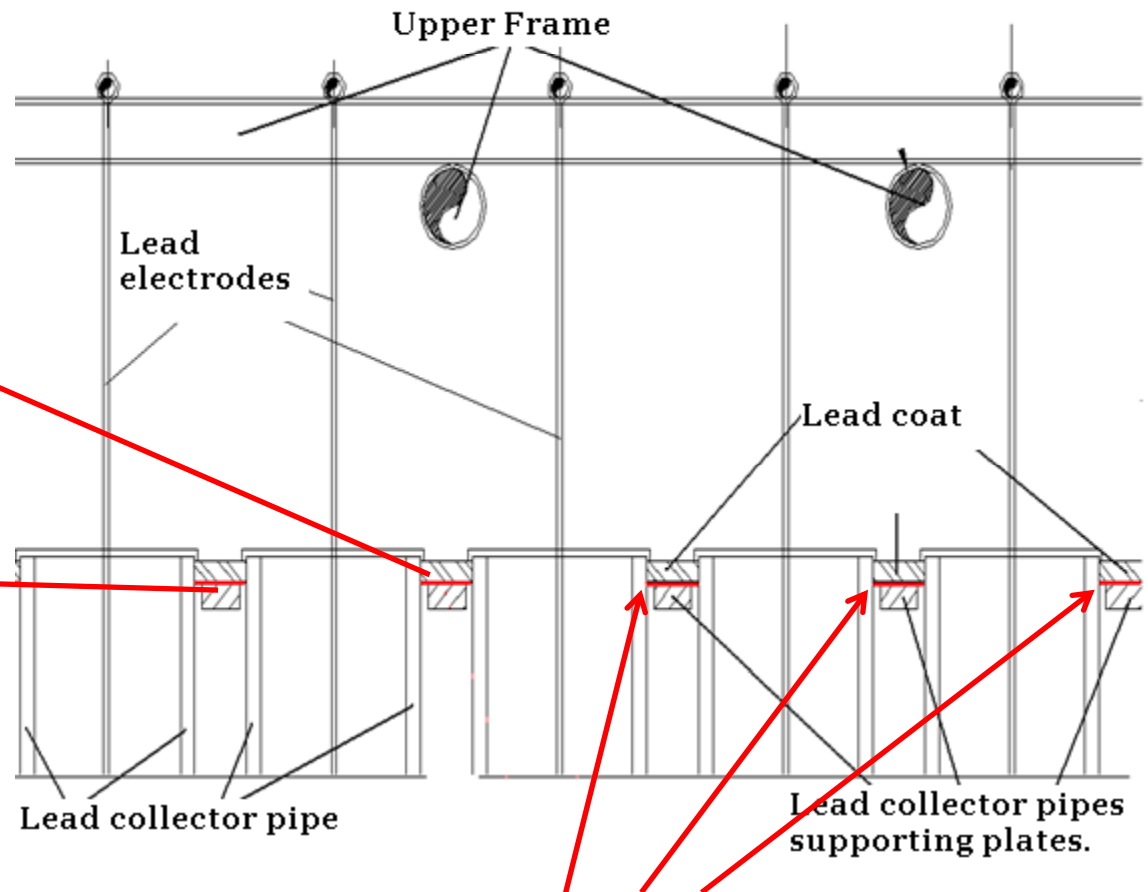
Constant repairs due to accumulation of sulphates and corrosion of steel and lead.

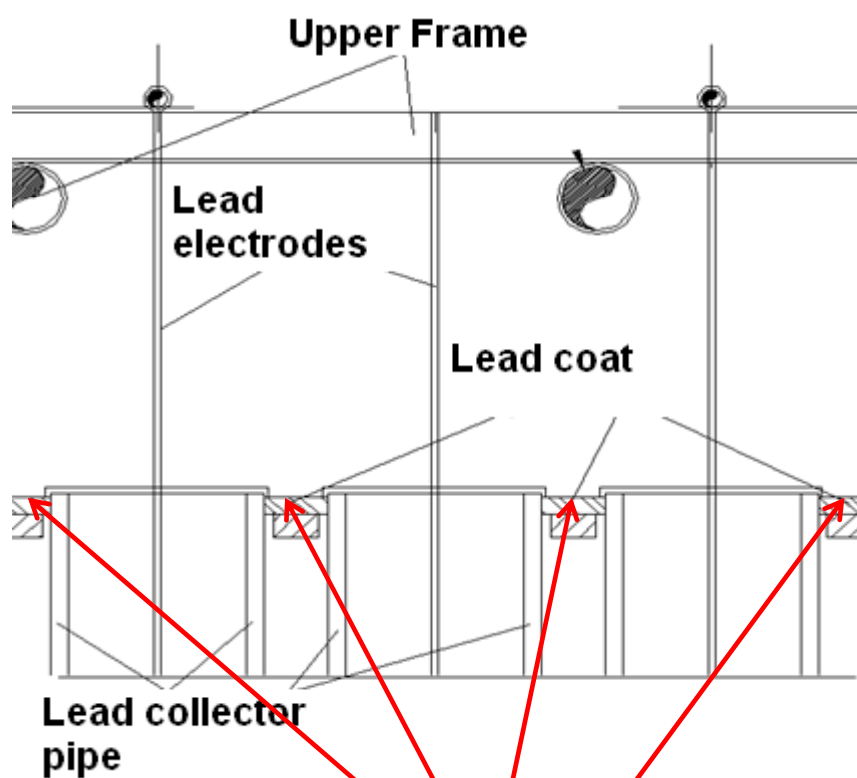
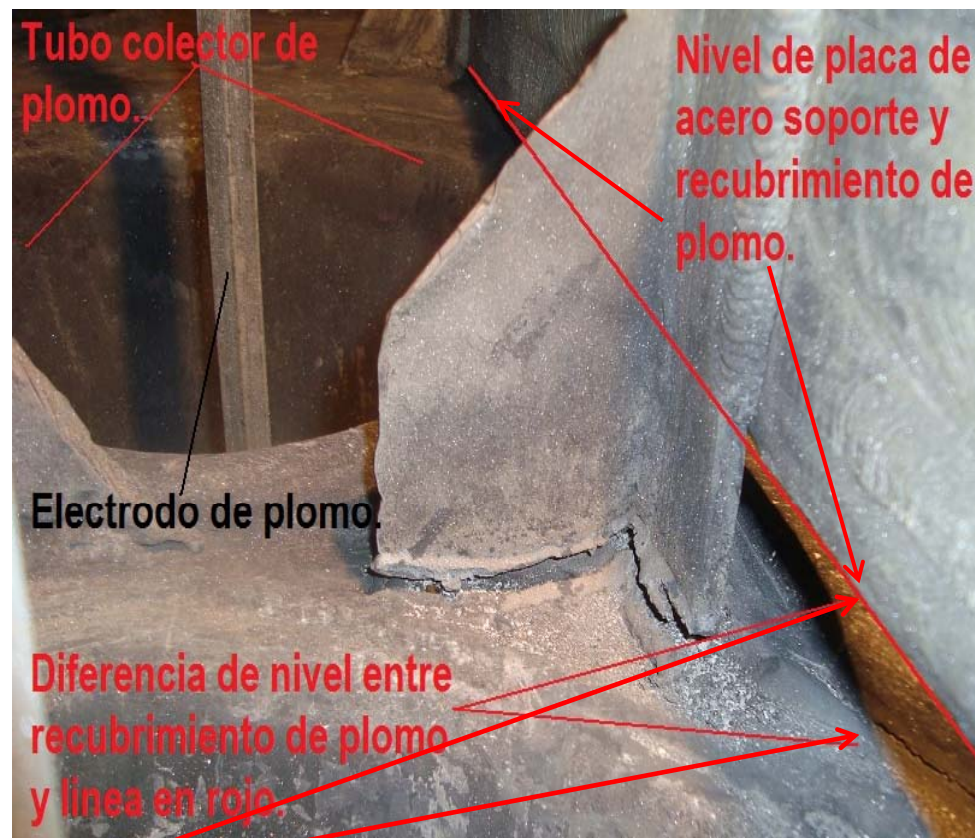
-Partial corrosion of steel support plate deforming downwards of the superior part of the lead collector pipes, creating hazardous conditions for operational and maintenance personnel with access to these WESPs.

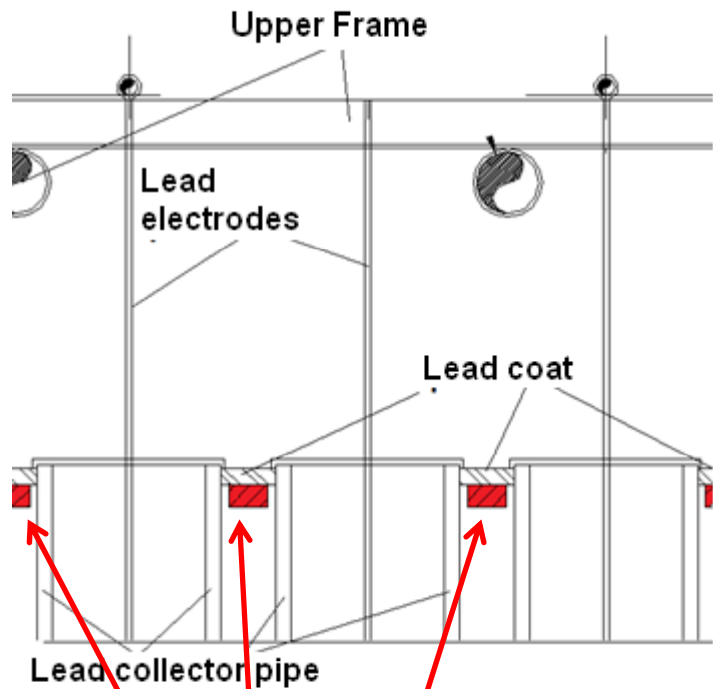
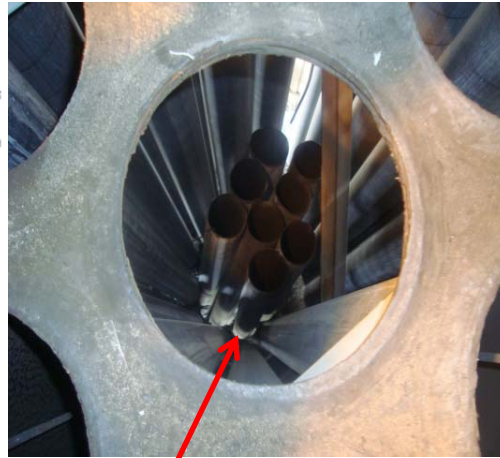
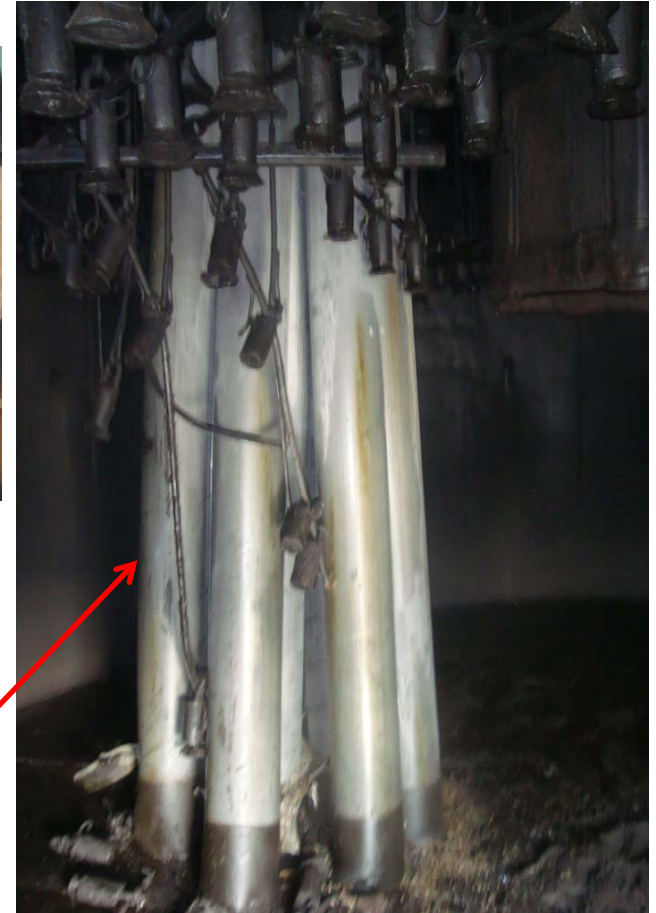
Total corrosion of steel support plate, completely collapsing lead collector pipes

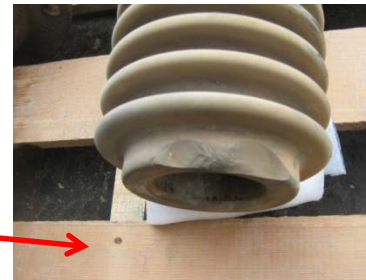
Broken or cracked ceramic insulators which cause risk of bending, diminishing WESP operational performance.

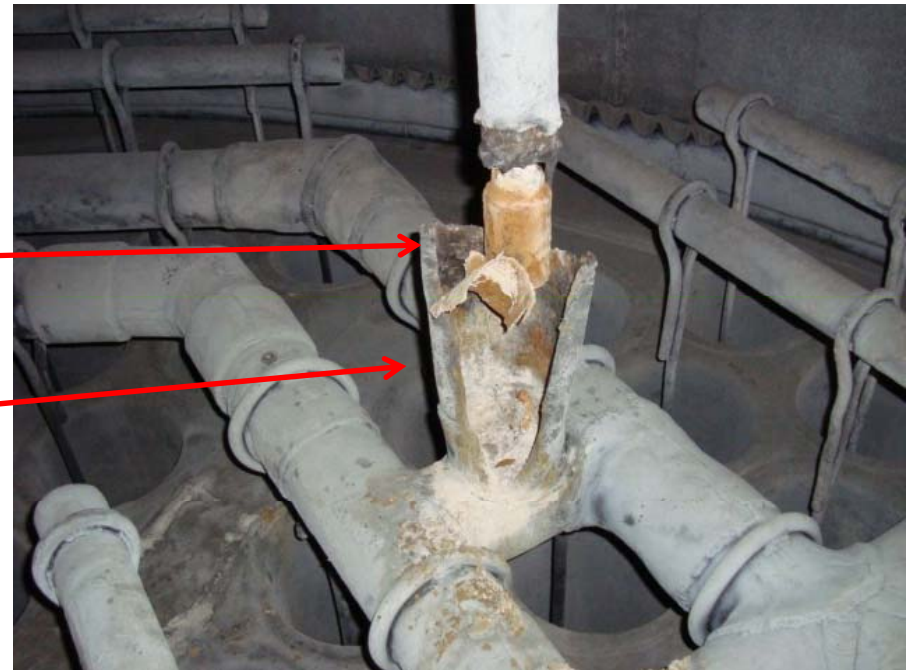
Total corrosion of charge pole and union between charge pole and upper frame. Causing unevenness between electrode and pipe.

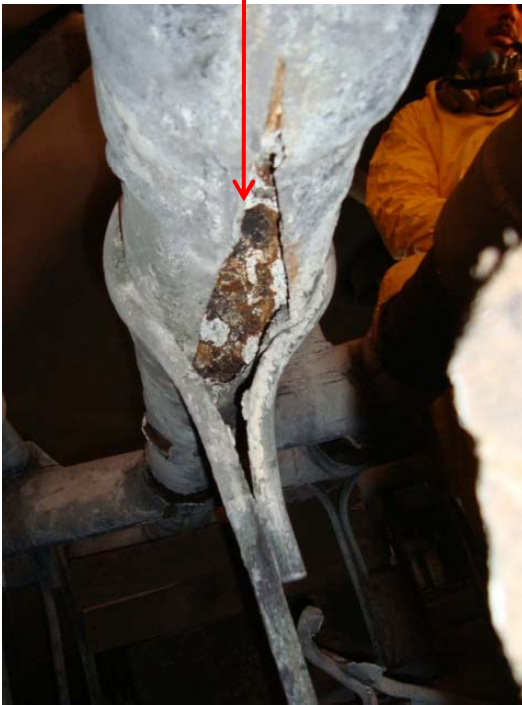
- Uneven and corroded upper frame

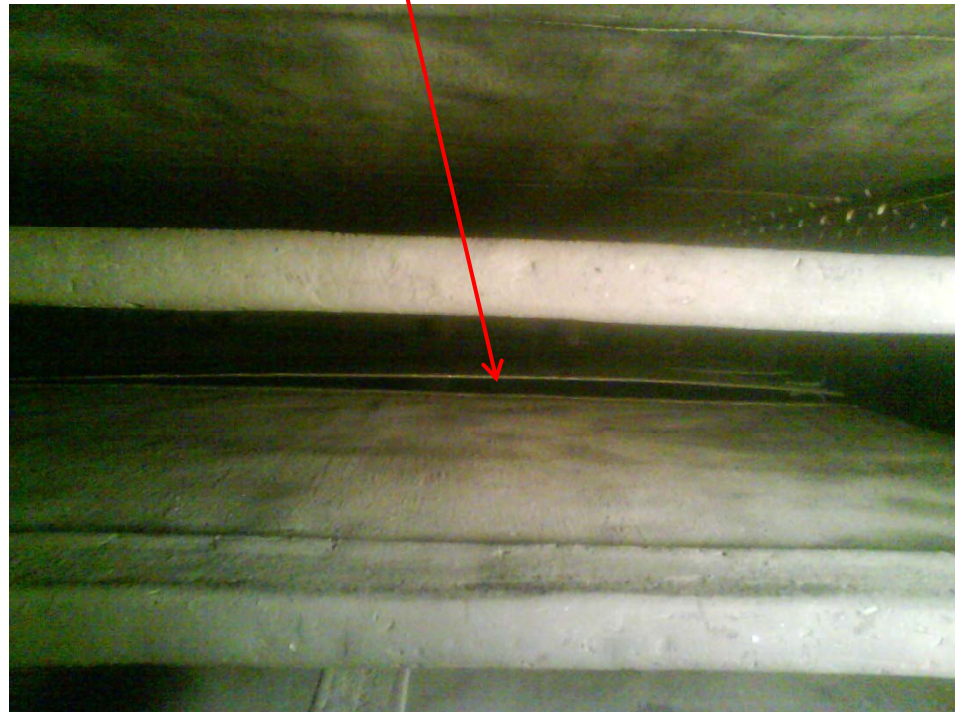
Collapsed collector plates

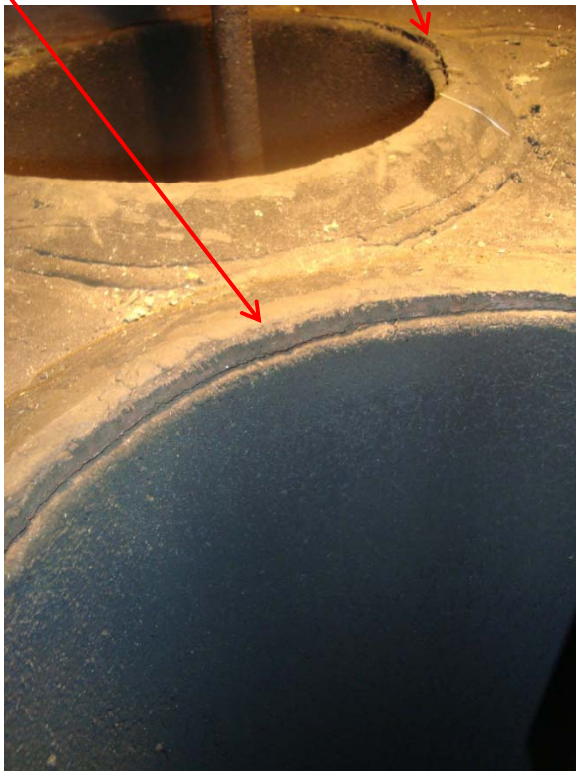
Deformed and cracked collector pipes

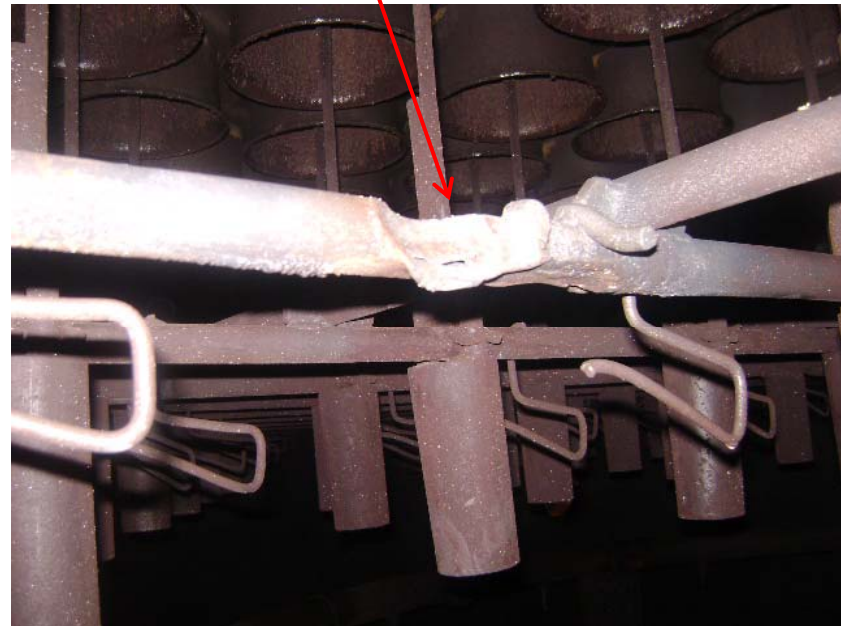
Corroded and uneven lower frame.

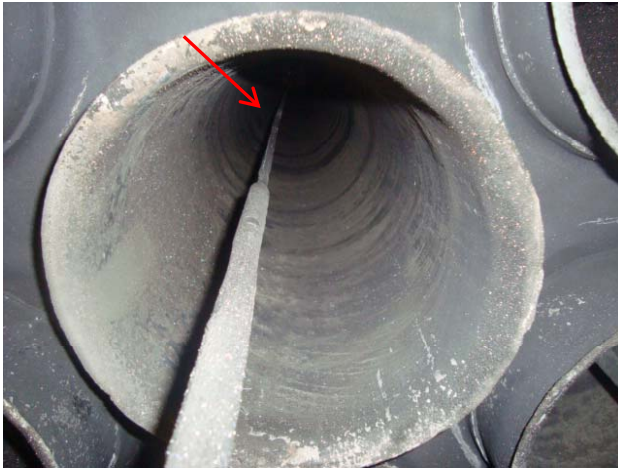
Electrodes out of center

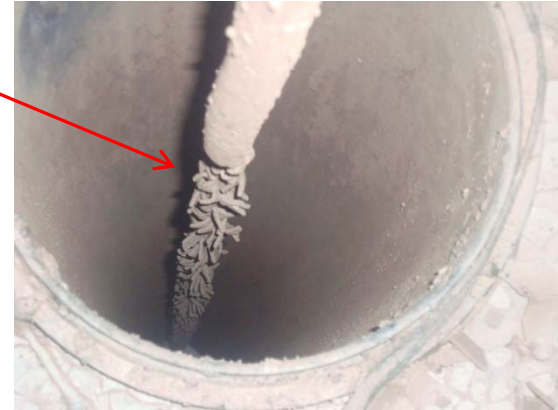
Electrodes with no edges which prevents **Crown effect** from happening and causes a failure in particle collection.

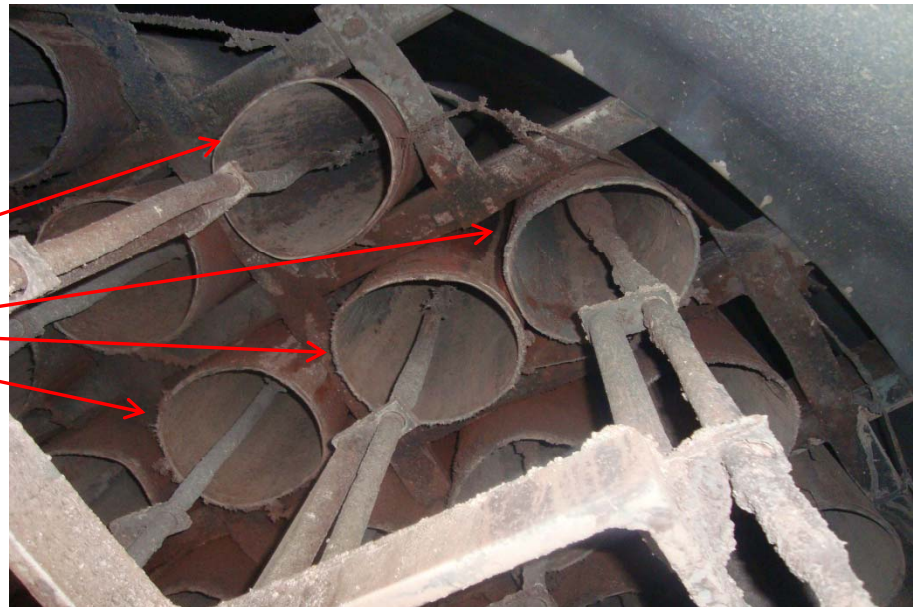
Damaged electrodes with no edges.

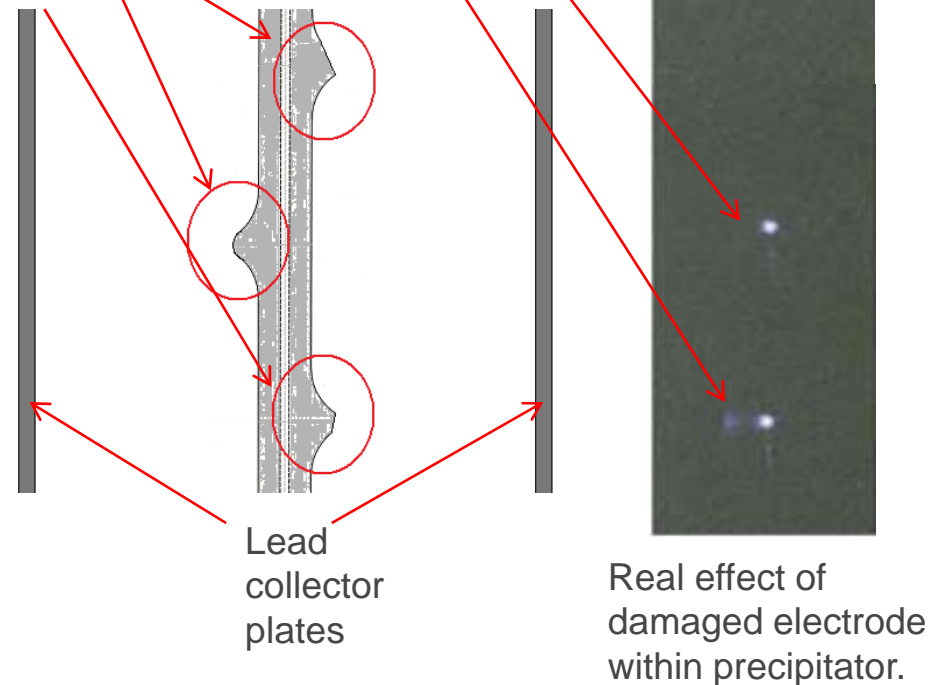
Centered electrode but without vertex. It does not cause bends but does not perform its particle collecting task, due to the fact that it does not perform a Crown effect.

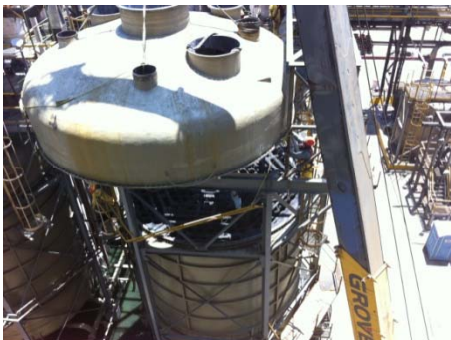
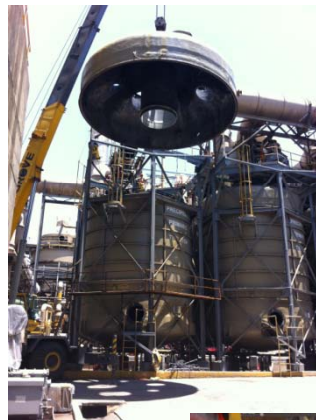
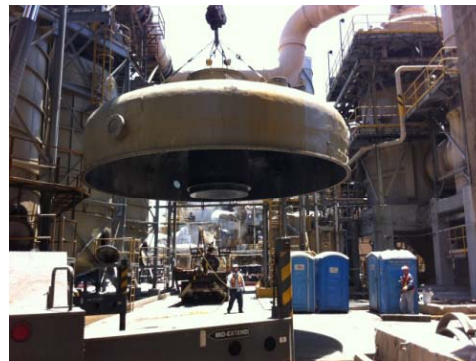
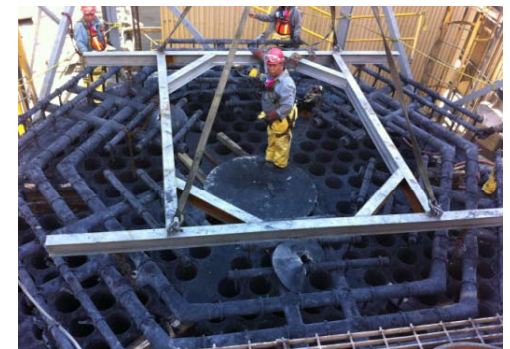
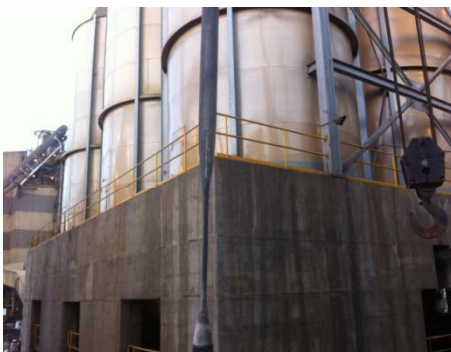
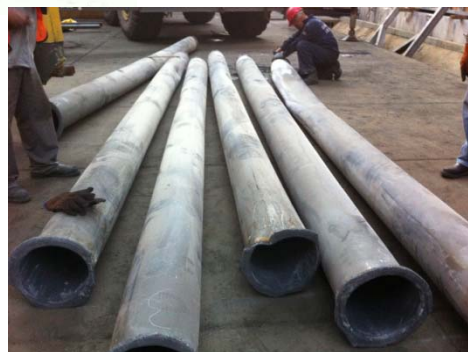
Problem: Deformed lead pipes

Solution: Dismounting of upper dome, upper frame, lead pipes, repairing of pipes and installation of components.
