GAMHERSA
S.A. DE C.V.

PRACTICAL SOLUTIONS
FOR ANY KIND OF
TECHNOLOGY WESP AND
LEAD EQUIPMENT IN
GENERAL.

Topic 1: Alteration of original design and manufacturing of:

Topic 2: Preventive maintenance of Wet electrostatic precipitators
WESP and discharge electrodes for WESP.

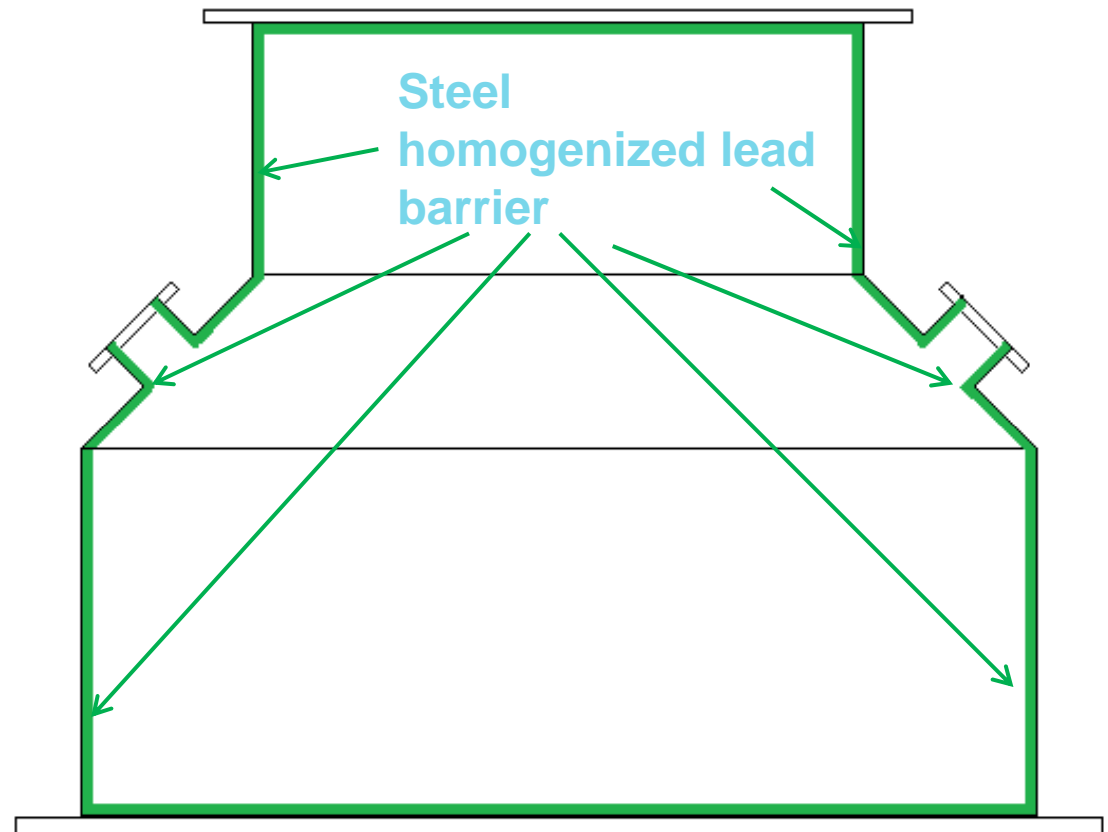
Steel manufacturing due to general wear out.

Installation of a steel homogenized lead surface with 6 mm. of thickness everywhere with possible contact with the flux.

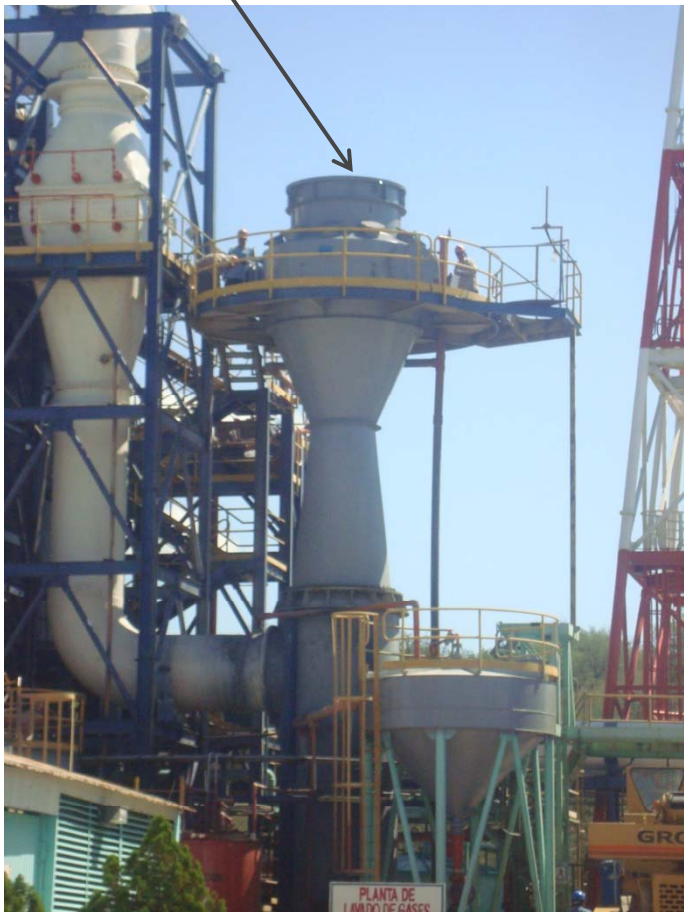
Final outlook

No False air intake in the flux nor variations in temperature.

No corrosion in steel Venturi nor in nearby installations .

Brick in excellent conditions.

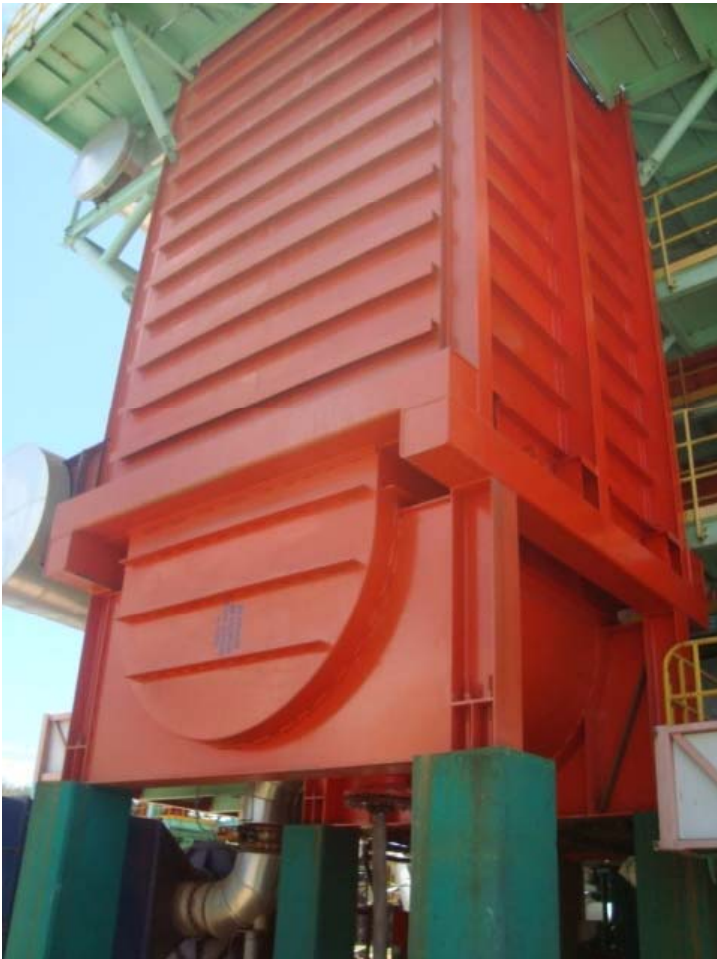
Final outlook:

- Optimum performance.
- No corrosion in steel condenser bottom nor in nearby installations .
- Brick in excellent conditions.
- A considerable maintenance cost reduction .
- Longer lasting life of the condenser.

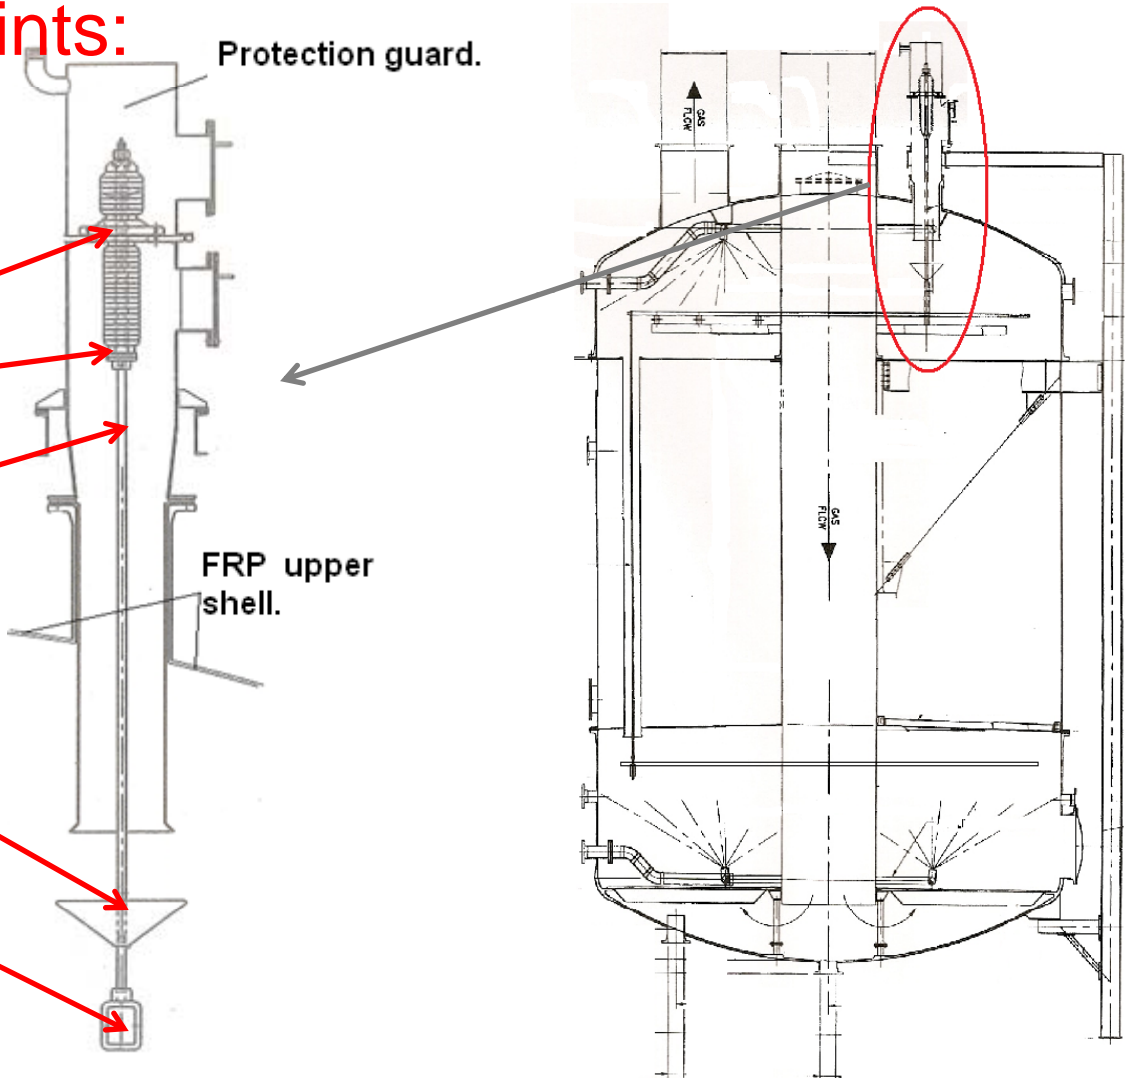
WESP with steel pipe technology
with concentric electrode.

-Ceramic insulator

Upper charge
pole.

Union between charge pole
and upper frame

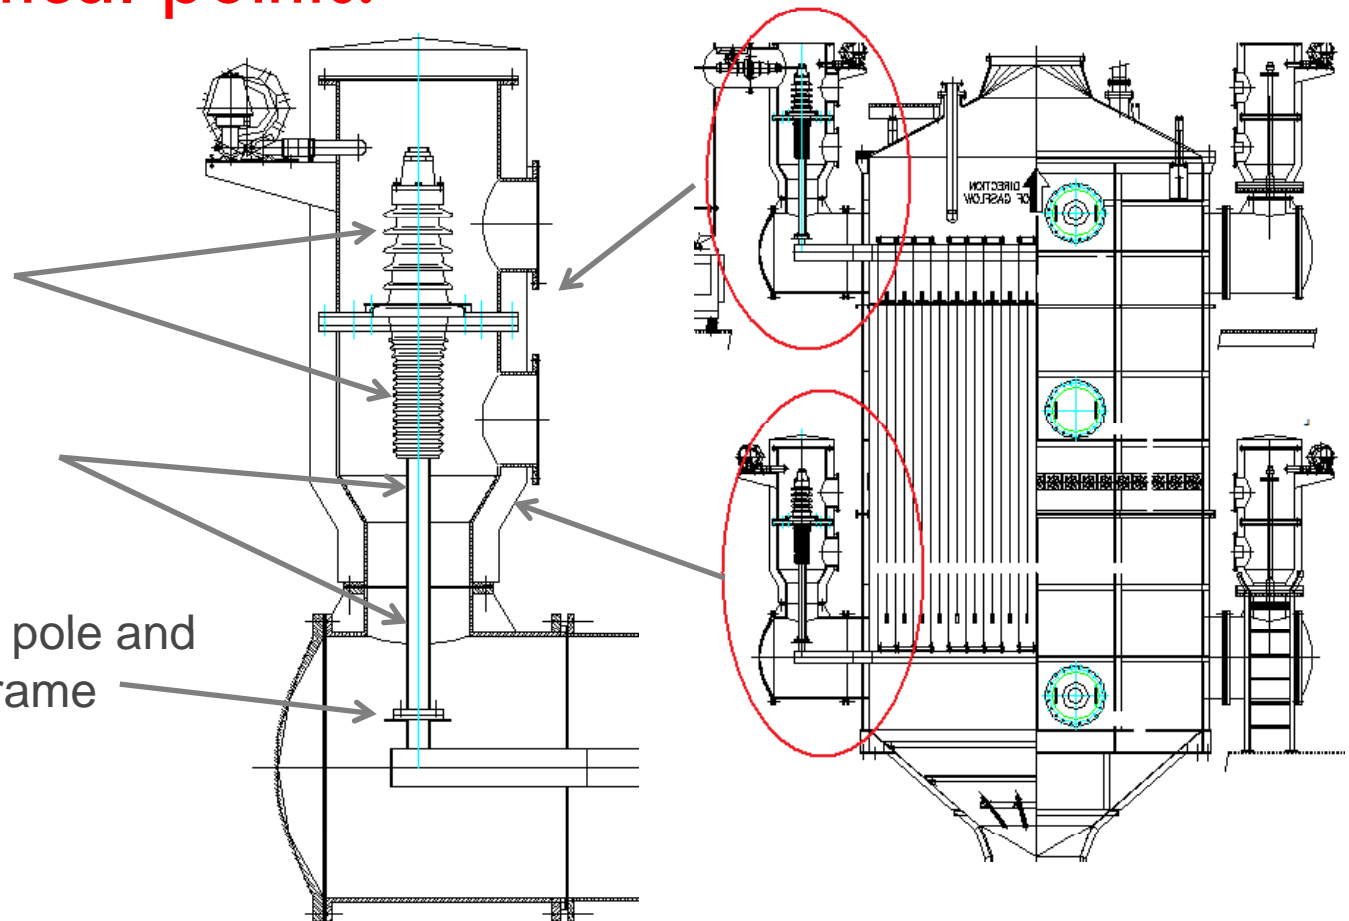
WESP with lead plate technology

-Ceramic insulator

-Charge pole.

Union between charge pole and upper frame or lower frame

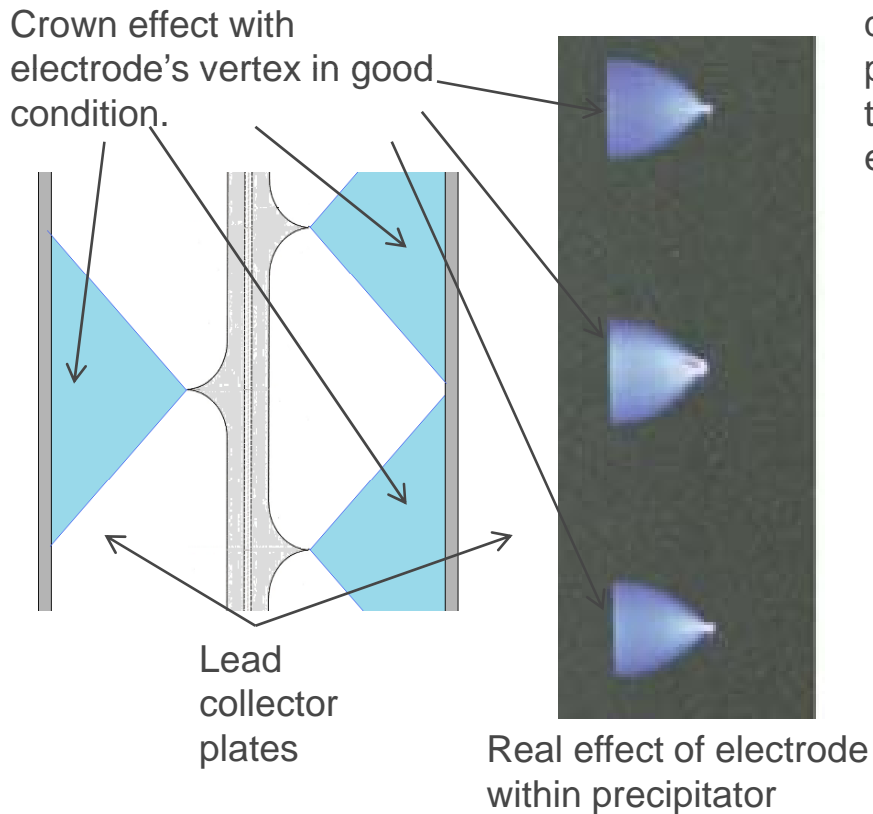
IMPORTANT: The fact that an electrode does not generate bends in electronic cabinet lectures, does not mean that it is working correctly; on the contrary, due to the fact that it is not performing its particle collecting task.

Centered electrode but without vertex. It does not cause bends but does not perform its particle collecting task, due to the fact that it does not perform a Crown effect.

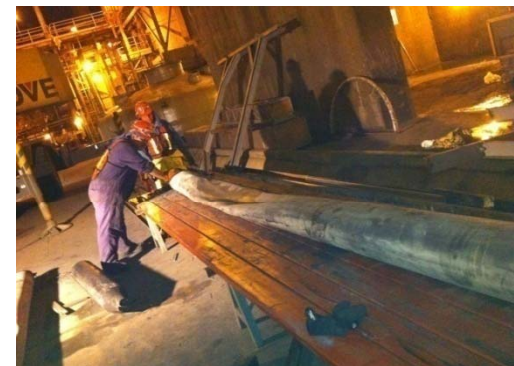
Problem: Deformed lead pipes

Solution: Dismounting of upper dome, upper frame, lead pipes, repairing of pipes and installation of components.
